Hyper+ Freewheel Kit - installation manual

Compatible with all HyperHubs (except Version 1)

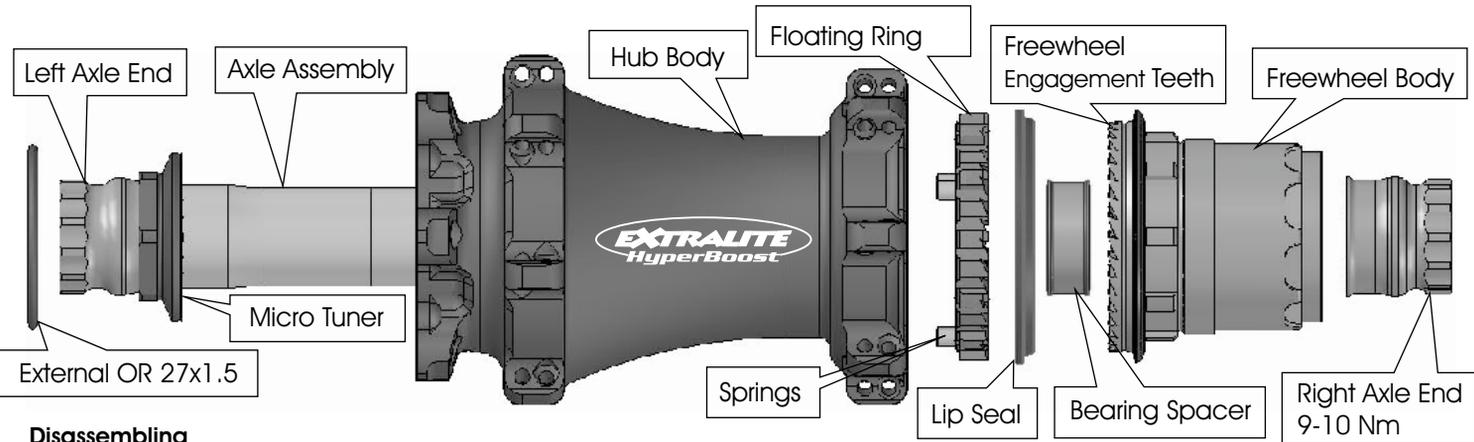
- 1) Hold Left Axle End with a 17mm closed wrench (5mm hex wrench for 135mm).
- 2) Unscrew Right Axle End with another 17mm closed wrench (5mm hex wrench for 135mm).
- 3) Pull Freewheel Body and remove it.
- 4) Extract Bearing Spacer.
- 5) Remove Lip Seal from Hub Body.
- 6) Remove Floating Ring from Hub Body, you'll find 3 tiny springs on its back side.
- 7) Push out Axle Assembly and completely extract it from disc side.

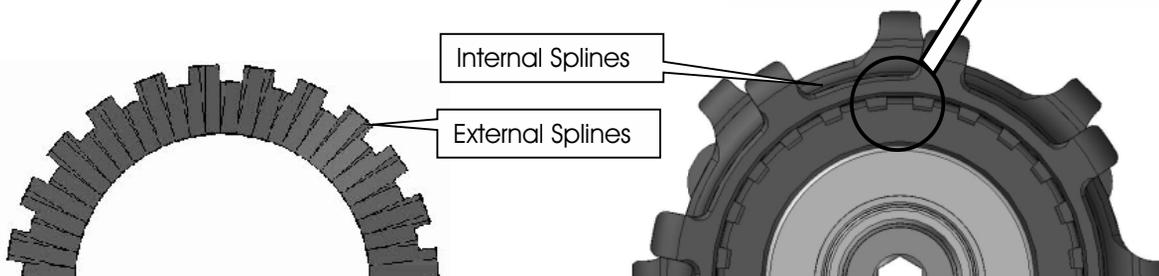
Clean and degrease perfectly hubshell internal splines, all of them.

Check with eye magnifier both the 2 rows of splines (12 + 12T) see image.

When riding HyperHubs with dirt inside the hard particles of sand can badly grind the hubshell splines. Shortly the sand wears the hub-shell splines till the "floating ring" will not move freely anymore. This easily causes an uncomplete freewheel engagement and damages permanently the newly installed freewheel parts. In this case replacing "floating ring" and/or "Freewheel body" does not solve. The expensive hub-shell should be replaced (or eventually sent back for re-sharpening).
