Special Freewheel Kit - installation manual

HyperBoost R - HyperRear 2 - HyperCamber 2 - Hyper JR - Hyper VR

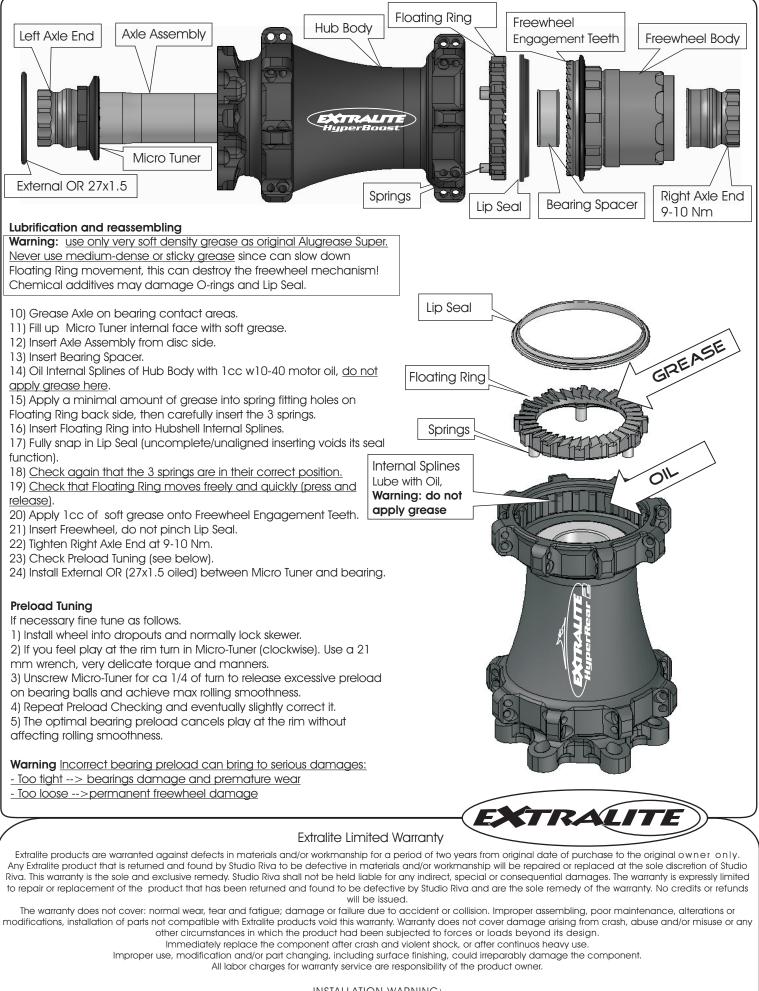
Disassembling

- 1) Hold Left Axle End with a 17mm closed wrench (5mm hex wrench for 135mm).
- 2) Unscrew Right Axle End with another 17mm closed wrench (5mm hex wrench for 135mm).
- 3) Pull Freewheel Body and remove it.
- 4) Extract Bearing Spacer.
- 5) Remove Lip Seal from Hub Body.
- 6) Remove Floating Ring from Hub Body, you'll find 3 tiny springs on its back side.
- 7) Push out Axle Assembly and completely extract it from disc side.

Cleaning

8) Clean all parts (Do not use aggressive solvents).

- 9) Clean very carefully all Internal Splines.
- Warning: even one small debris can void freewheel engagement.

Hubshell Splines Check - IMPORTANT!

Clean and degrease perfectly hubshell internal splines, all of them. <u>Check with eye magnifyer</u> both the 2 rows of splines (12 + 12T) see image. Once hub-shell internal is perfectly clean check well with eye magnifyer both the 2 rows of splines (12 + 12T) see image. <u>Every spline corners (clockwise corners) should be well square</u> and flat.
